CT imaging of inflatable penile prosthesis complications: a pictorial essay

Huan L. Chou, Nancy A. Mohsen, Bruce B. Garber & David C. Feldstein

Abdominal Radiology

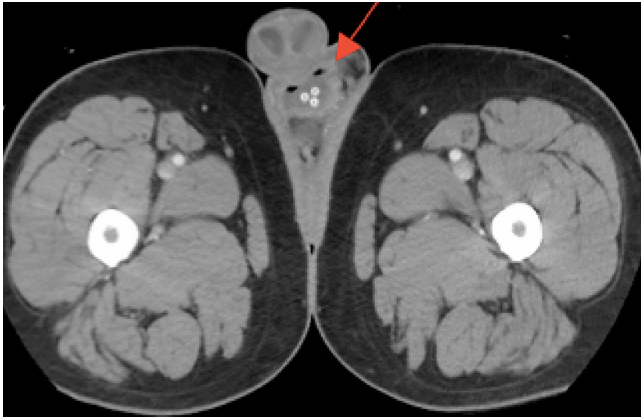
CT typically reveals skin thickening, soft tissue swelling, or fat stranding. In patients with abscess formation, a rim-enhancing fluid collection with or without gas may be visualized surrounding the IPP components (Fig. 14). Skin irregularity and ulceration with IPP components exposure through the skin also may occur (Fig. 15).

Fig. 14. Axial CT image shows a rim-enhancing fluid collection surrounding connecting tubing with two foci of gas within the collection (red arrow), consistent with abscess formation.

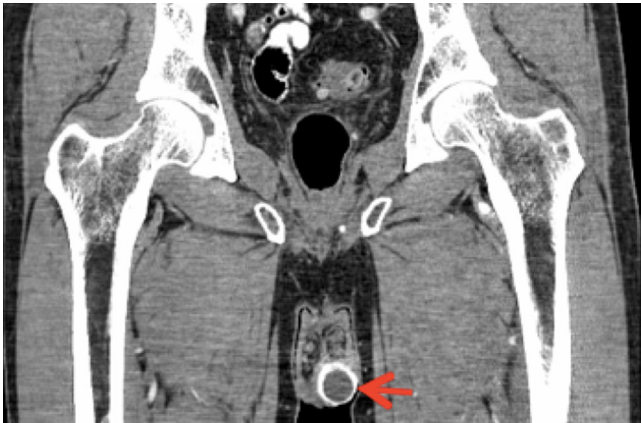
Fig. 15. Coronal CT image shows the pump eroding through the left hemi-scrotal skin (red arrow). There is scrotal skin thickening and fat stranding adjacent to the pump, consistent with scrotal cellulitis, and ulceration caused by IPP infection.

- a. **Pump erosion:** In our series, one patient had pump erosion through the scrotal wall with a scrotal skin defect identified by CT (Fig. 15), in association with infection.
- b. **Pump malposition/migration:** The pump is ideally located in a dependent portion of the scrotum usually in the midline. Pump migration or malposition can be diagnosed on CT if the pump is in any other position (Figs. 28, 29, 30). Pump malposition does not often occur in isolation. Commonly, it is secondary to other complications, such as a large hematoma or abscess displacing the pump. Therefore, when pump malposition is identified by the radiologist, it should spur additional search for the

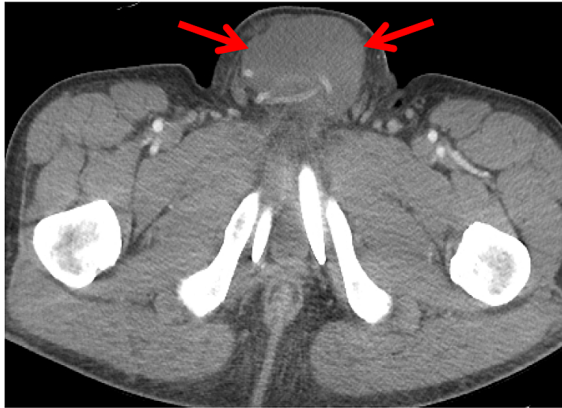
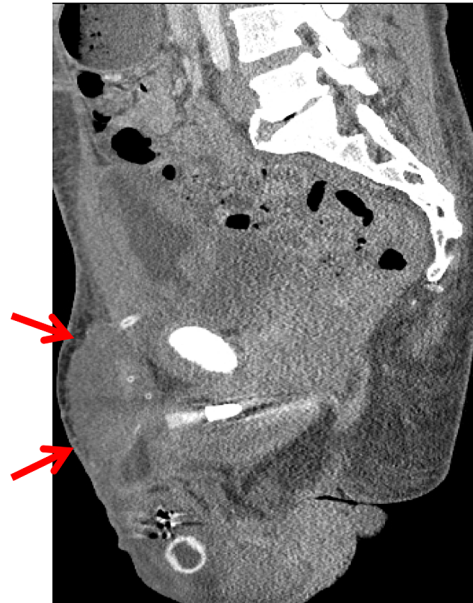
Two patients in our study presented with post-operative hematomas. In both cases, the patients had IPP surgery for the first time, and the hematoma occurred within 2 weeks post-surgery. Patients had pain, swelling, tenderness, and serosanguinous drainage from the incision site. CT revealed a collection of blood with fat stranding and soft tissue swelling (Figs. 16, 17). Both cases required surgical hematoma evacuation; cultures from the evacuated hematoma revealed no infection.

Figs. 16 and 17. Axial (left) and sagittal (right) CT images demonstrate an intermediate density fluid collection surrounding the IPP connector tubing, located in the

anterior pelvic subcutaneous soft tissue (red arrows). These findings are most consistent with a post-operative hematoma.

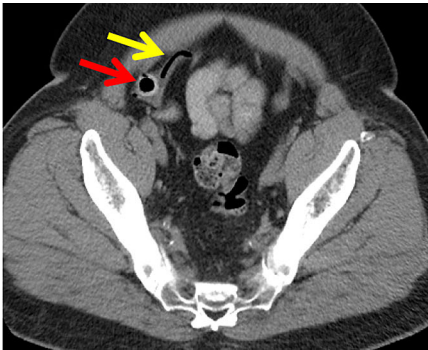
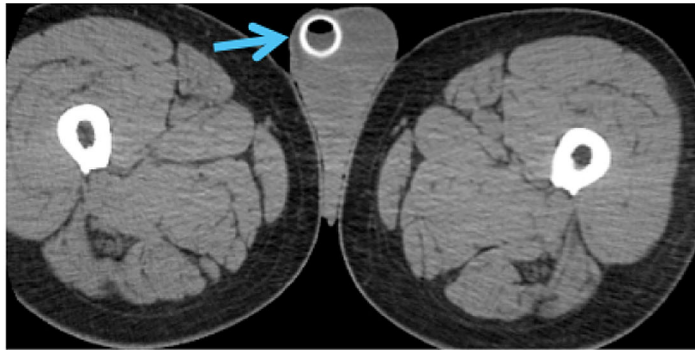
neous collapse of the cylinders and the reservoir or gas in or surrounding the IPP components. In our study, 53.8% of cases with fluid leak had gas within or surrounding the IPP components (Figs. 18, 19).

Figs. 18 and 19. Axial CT images demonstrate air within the IPP reservoir (red arrow), connector tubing (yellow arrow), and scrotal pump (blue arrow). This is indicative of a fluid leak, leading to device malfunction.

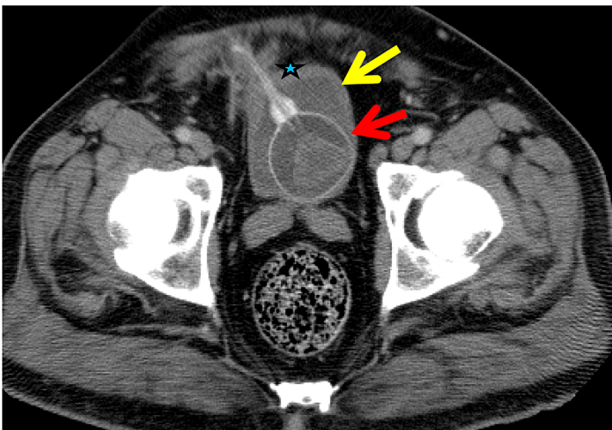
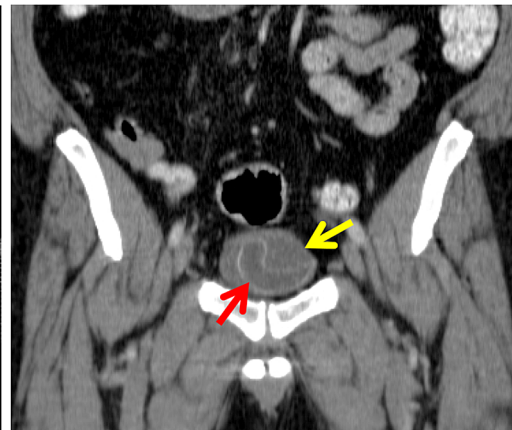
Reservoir complications include reservoir leak and erosion. Reservoir leak has been discussed in the previous system fluid leak section. In this section, I will concentrate on reservoir erosion. We found one case with penile implant infection complicated by reservoir erosion into the bladder (Figs. 20, 21). The patient had undergone 5 IPP surgeries and complained of scrotal pain, scrotal incision drainage, fever, and gross hematuria at presentation. In such emergent scenario, CT is the best modality as it sufficiently demonstrated the complication and was readily available.

Figs. 20 and 21. Axial (left) and coronal (right) CT images demonstrate erosion of the reservoir (red arrows) into the urinary bladder (yellow arrows). Bladder wall thickening (small blue star) and perivesical inflammatory reaction are clearly visible.

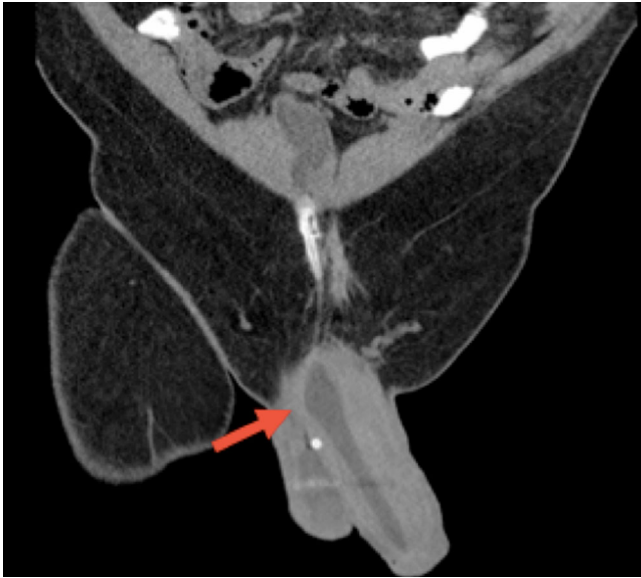
Fig. 22. Coronal CT image shows an aneurysm (red arrow) of the proximal right cylinder.

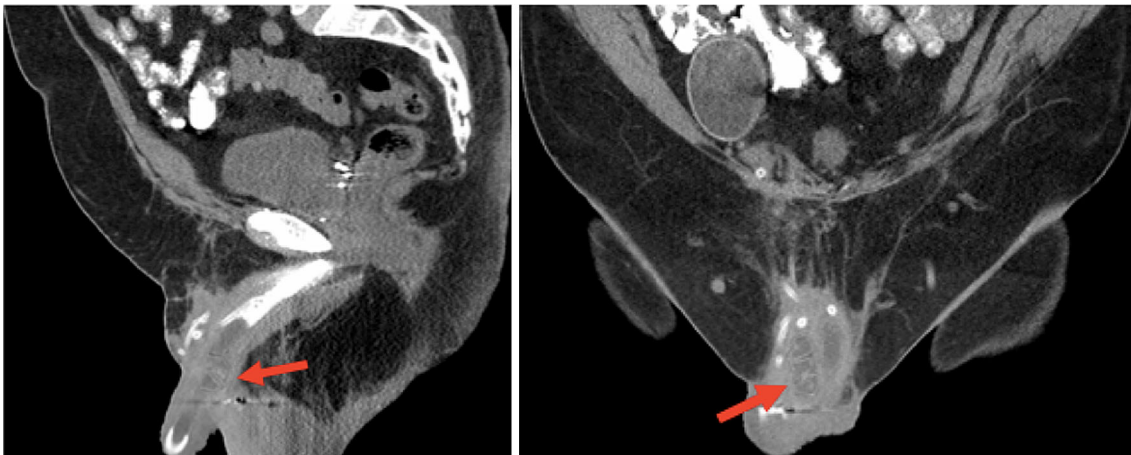
Figs. 23 and 24. Sagittal (left) and coronal (right) CT images demonstrate infolding of the right cylinder (red arrows).

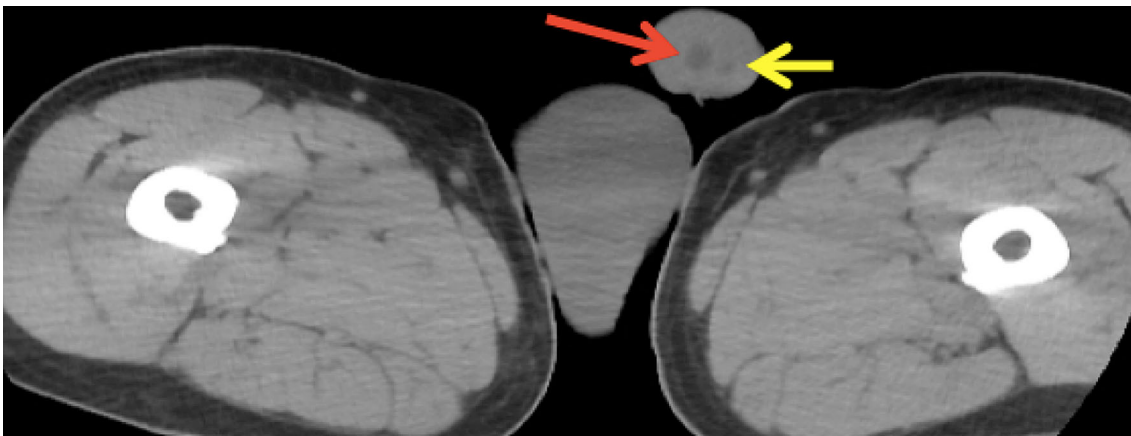
Fig. 25. Axial CT image demonstrates the left cylinder (yellow arrow) is located more lateral than the right cylinder (red arrow). Erosion of the right cylinder into the urethral lumen was identified during surgery.

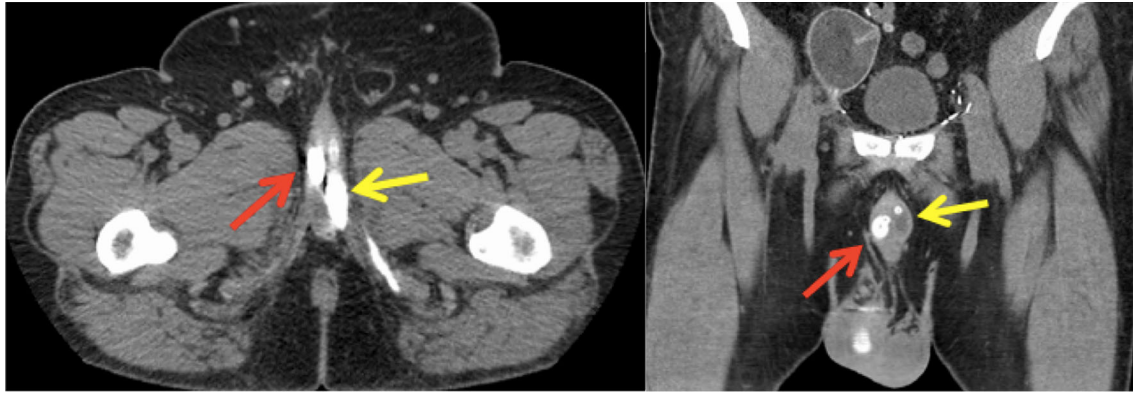
Figs. 26 and 27. Axial (left) and coronal (right) CT images show right cylinder rear tip extender (red arrow) and left cylinder/rear tip extender (yellow arrow). At the axial image (Fig. 26), the right rear tip extender is anteriorly migrated due

to kinking and enfolding of the right cylinder (Figs. 23, 24). On the coronal view (Fig. 27), we already see the rear tip extender on the right. However, on the left, the cylinder is visualized. This indicates right cylinder anterior migration.

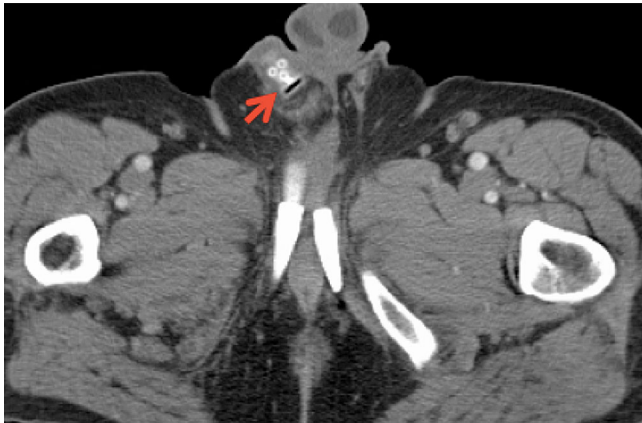
Fig. 28. Axial CT image demonstrates cephalad pump migration (red arrow), adjacent to the penile shaft base. Expected pump location is in the midline within the scrotum.

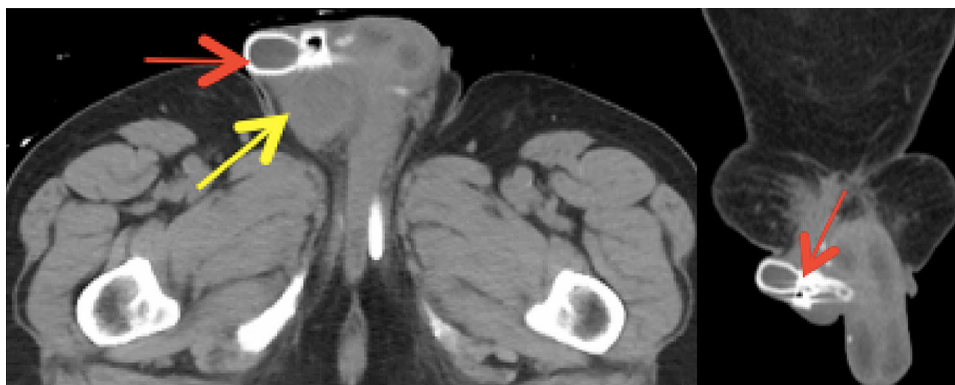
cause. In our series, one of the patients' pumps was pushed to a transverse position due to a large adjacent abscess.

Figs. 29 and 30. Axial (left) and coronal (right) CT images reveal scrotal pump (red arrow) is transverse lying high in the scrotum abutting the skin surface. The right testicle (yellow

arrow) appears superiorly displaced into the inferior aspect of the right inguinal canal, just posterior to the transversely oriented pump.

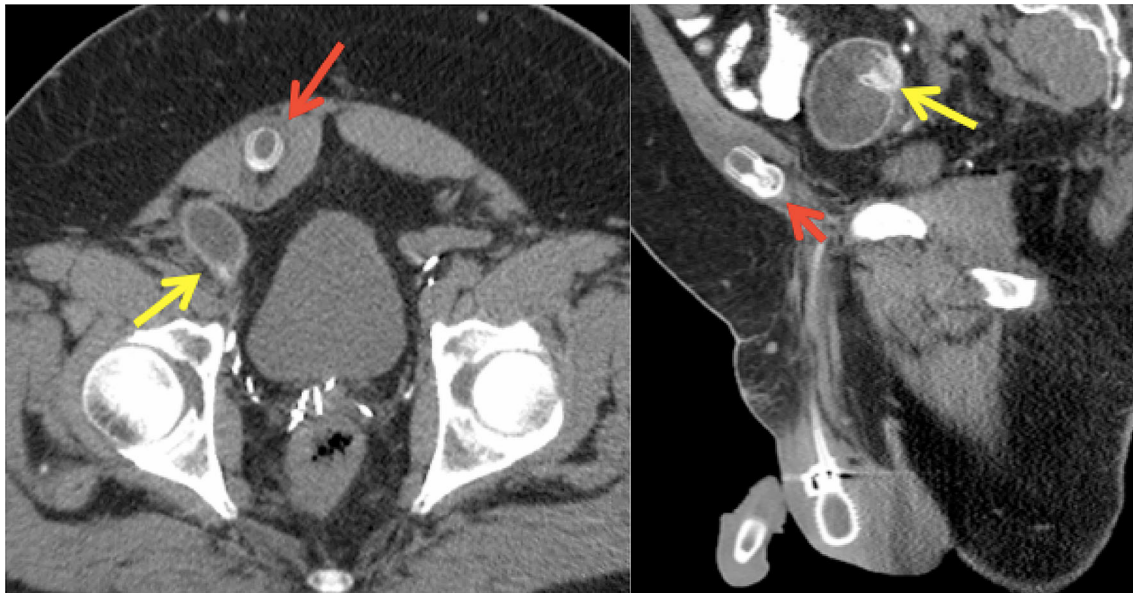
Retained IPP components can be easily seen on CT (Figs. 31, 32). When an IPP is being replaced, some surgeons leave the old reservoir in situ, then place a new IPP. This results in a retained, deflated, nonfunctioning old reservoir. Occasionally, rear tip extenders may be inadvertently left in the proximal corpora. Retained reservoirs may cause complications such as bladder erosion, infection, adhesions, or compression of adjacent structures [18, 19]. Retained reservoirs are easily identified and should be described.

Figs. 31 and 32. Axial (left) and sagittal (right) CT images reveal a fluid filled intra-pelvic reservoir (yellow arrow) posterior to the right rectus muscle, along with a retained

reservoir from a previous IPP located in the abdominal wall posterior to the rectus abdominis and anterior to the transversalis fascia (red arrow).
