CT imaging of inflatable penile prosthesis complications: a pictorial essay

Huan L. Chou, Nancy A. Mohsen, Bruce B. Garber & David C. Feldstein

Abdominal Radiology

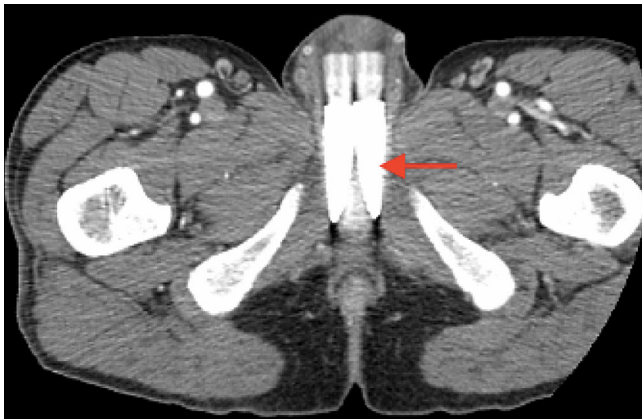
Fig. 3. Axial image of normal symmetric IPP cylinder tip extenders (red arrow).

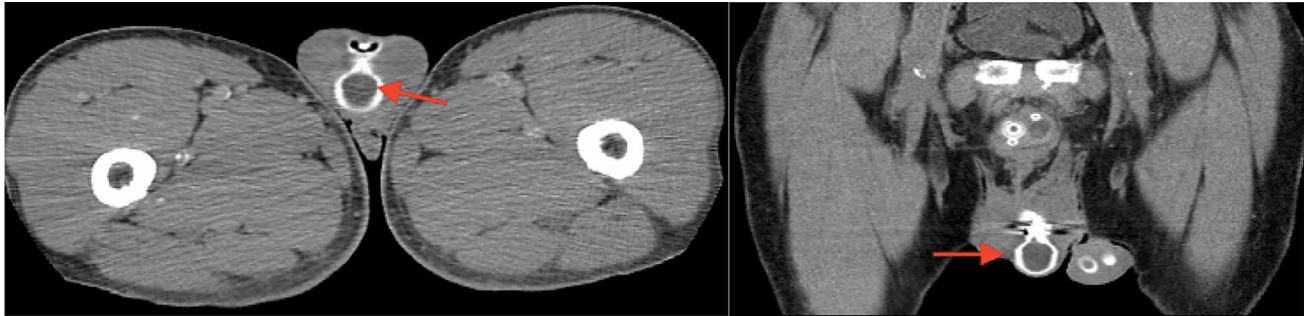
Figs. 4 and 5. Axial and coronal image of normal IPP pump location in the midline inferior scrotum between the testes (red arrow).

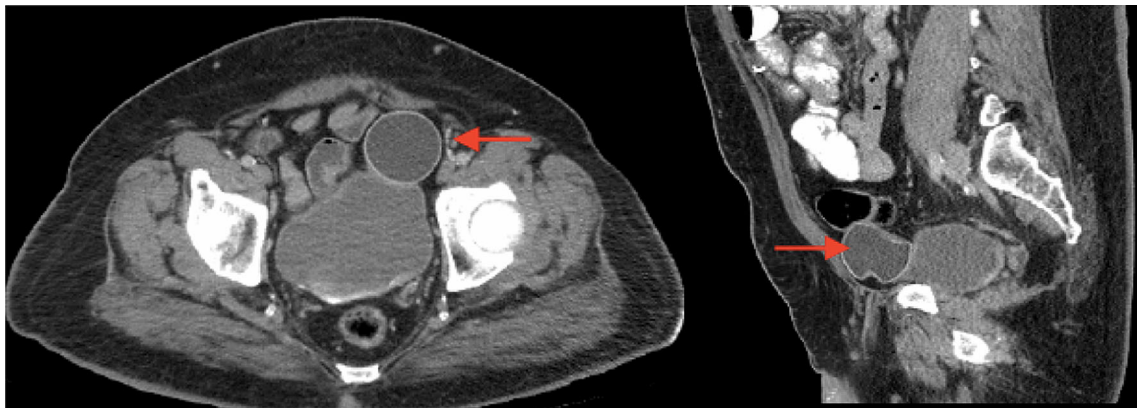
Figs. 6 and 7. Axial and coronal image of normal IPP reservoir location in the retropubic space anterior to the bladder (red arrow).

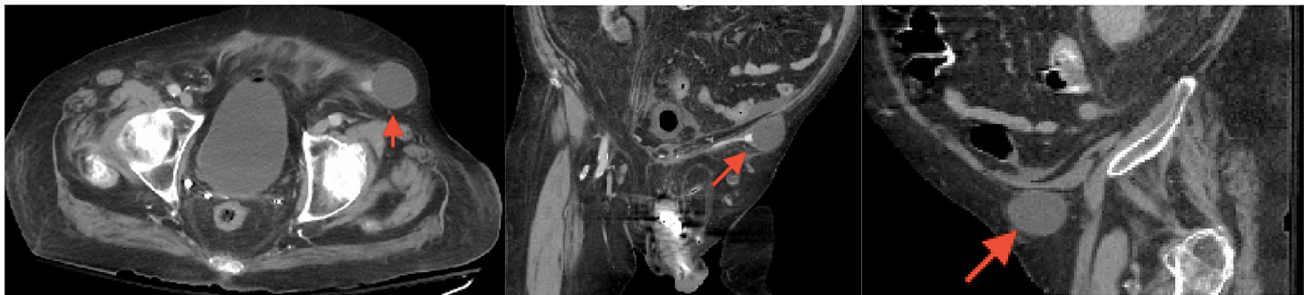
Figs. 8, 9, and 10. Axial, coronal, and sagittal images of normal IPP reservoir in left lower quadrant subcutaneous tissues (red arrow).

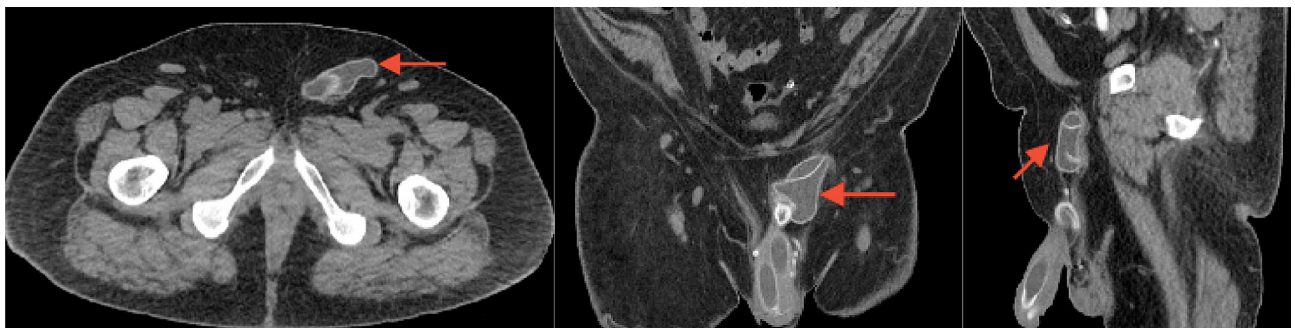
Figs. 11, 12, and 13. Axial, coronal, and sagittal images of normal IPP reservoir in the left inguinal canal (red arrow).
